CHAPTER 4

REPAIR SCHEMES AND COSTS

FOR

CUTS IN FLEXIBLE PAVEMENTS

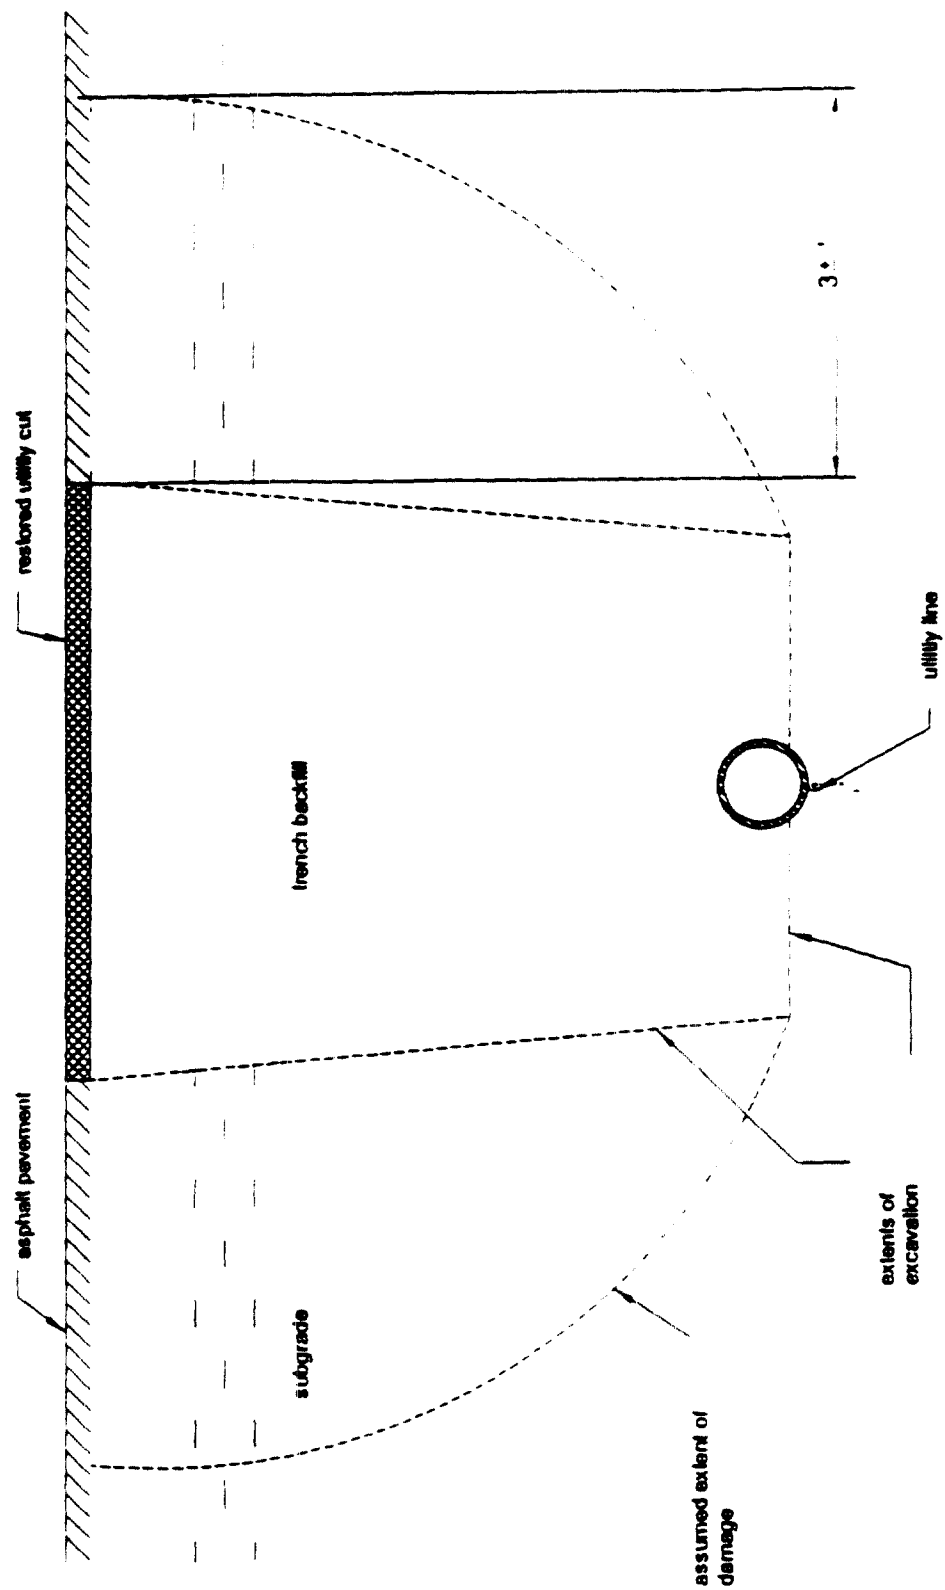
Deflection measurements and visual evaluation show that utility cuts ordinarily weaken the adjacent pavement, Figure 4.1. In the thirty-six (36) asphaltic concrete and macadam pavement sites studied in detail, Chapter 2, the damage extended beyond the edge of the cut in all directions for an average distance of 3 feet. Thus, for a typical utility cut excavation of 4 feet by 5 feet, the affected area of pavement was 10 feet by 11 feet. It was also shown, Chapter 2, that to restore the disturbed pavement to its original strength will require, under average conditions, the application of an overlay 1.75 inches thick.

FIG. 4.1. Zones of Weakened Subgrade Due to Utility Cut

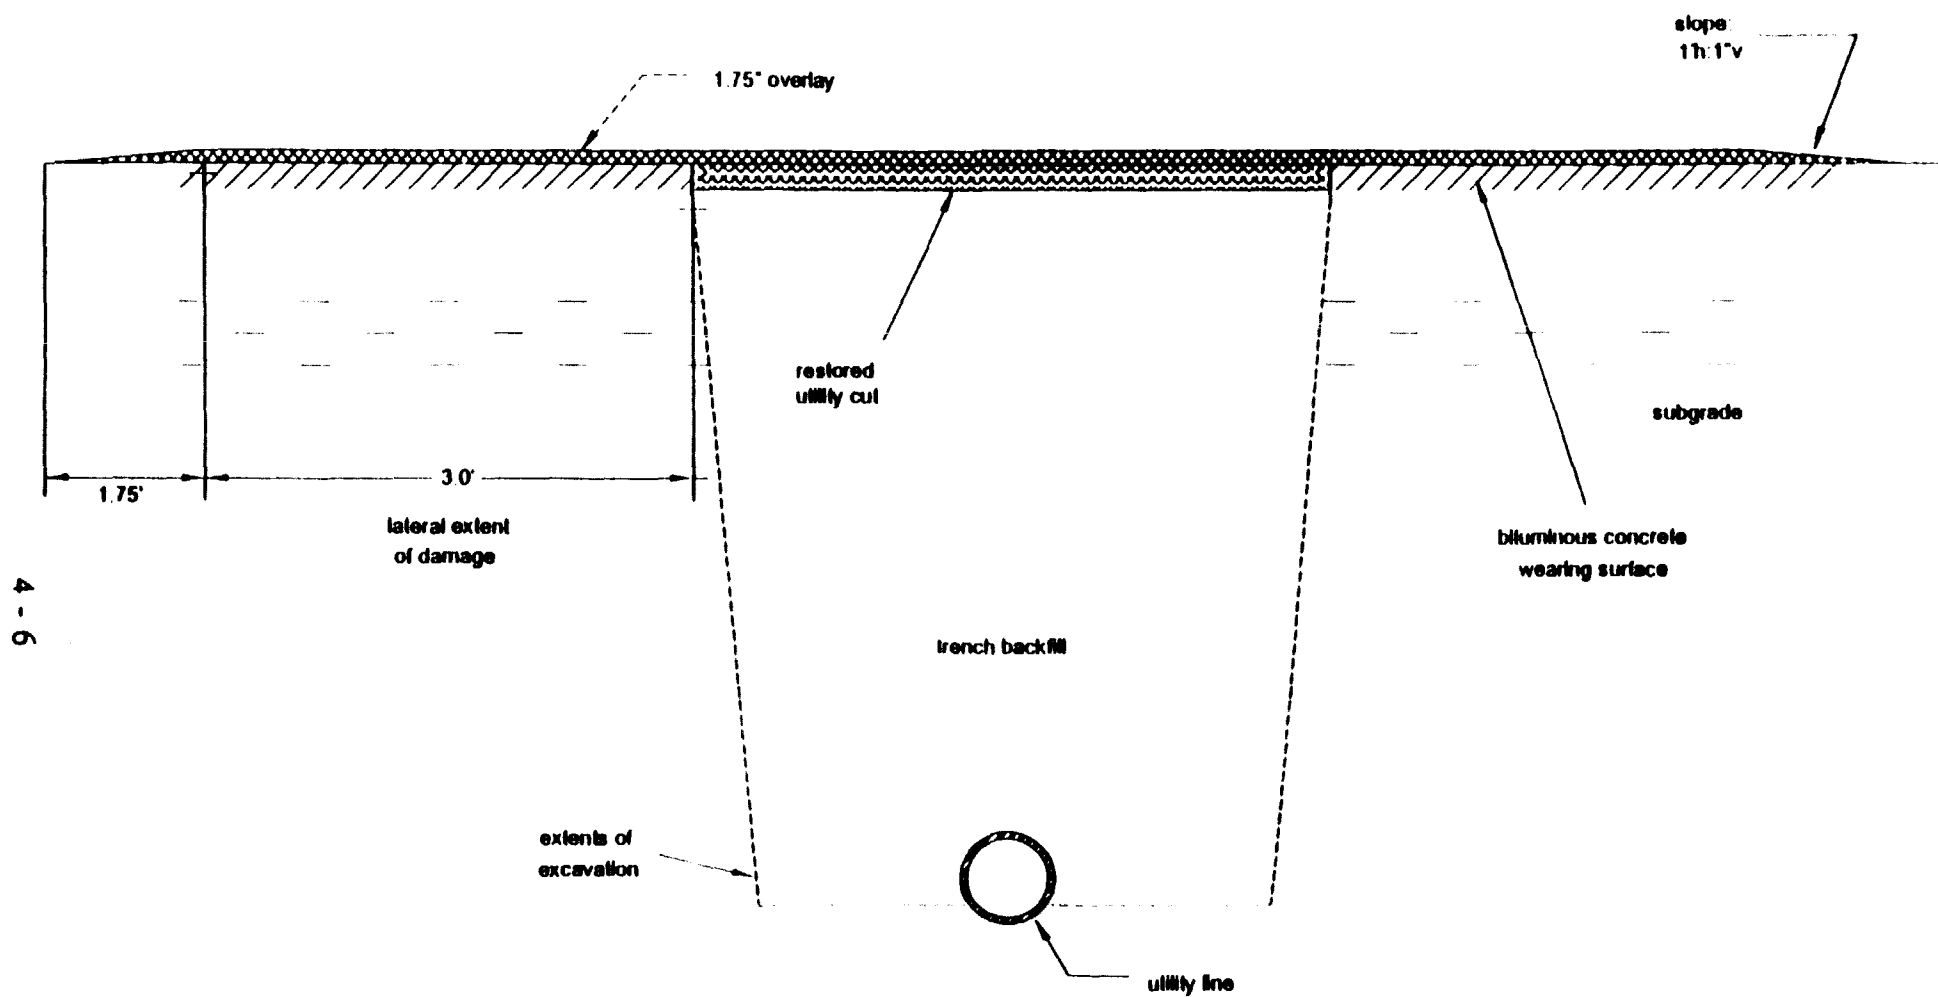
FIG. 4.2. Pavement Strengthened by 1.75 in. AC Overlay - Scheme 1

Scheme 1 consists of placing an additional 1.75 inch layer of AC over the patch and adjacent pavement, extending laterally a distance of 3 feet to all sides, then extending an additional 1.75 feet on a taper to zero at the original pavement surface. The new pavement surface thus would cover an area of approximately 196 square feet. The estimated cost of this technique, Figure 4.2, is \$1,000. This scheme, while likely acceptable strengthwise, is

not practical on a 196 square foot overlay because the edges (transition) would be rough and adversely affect rideability

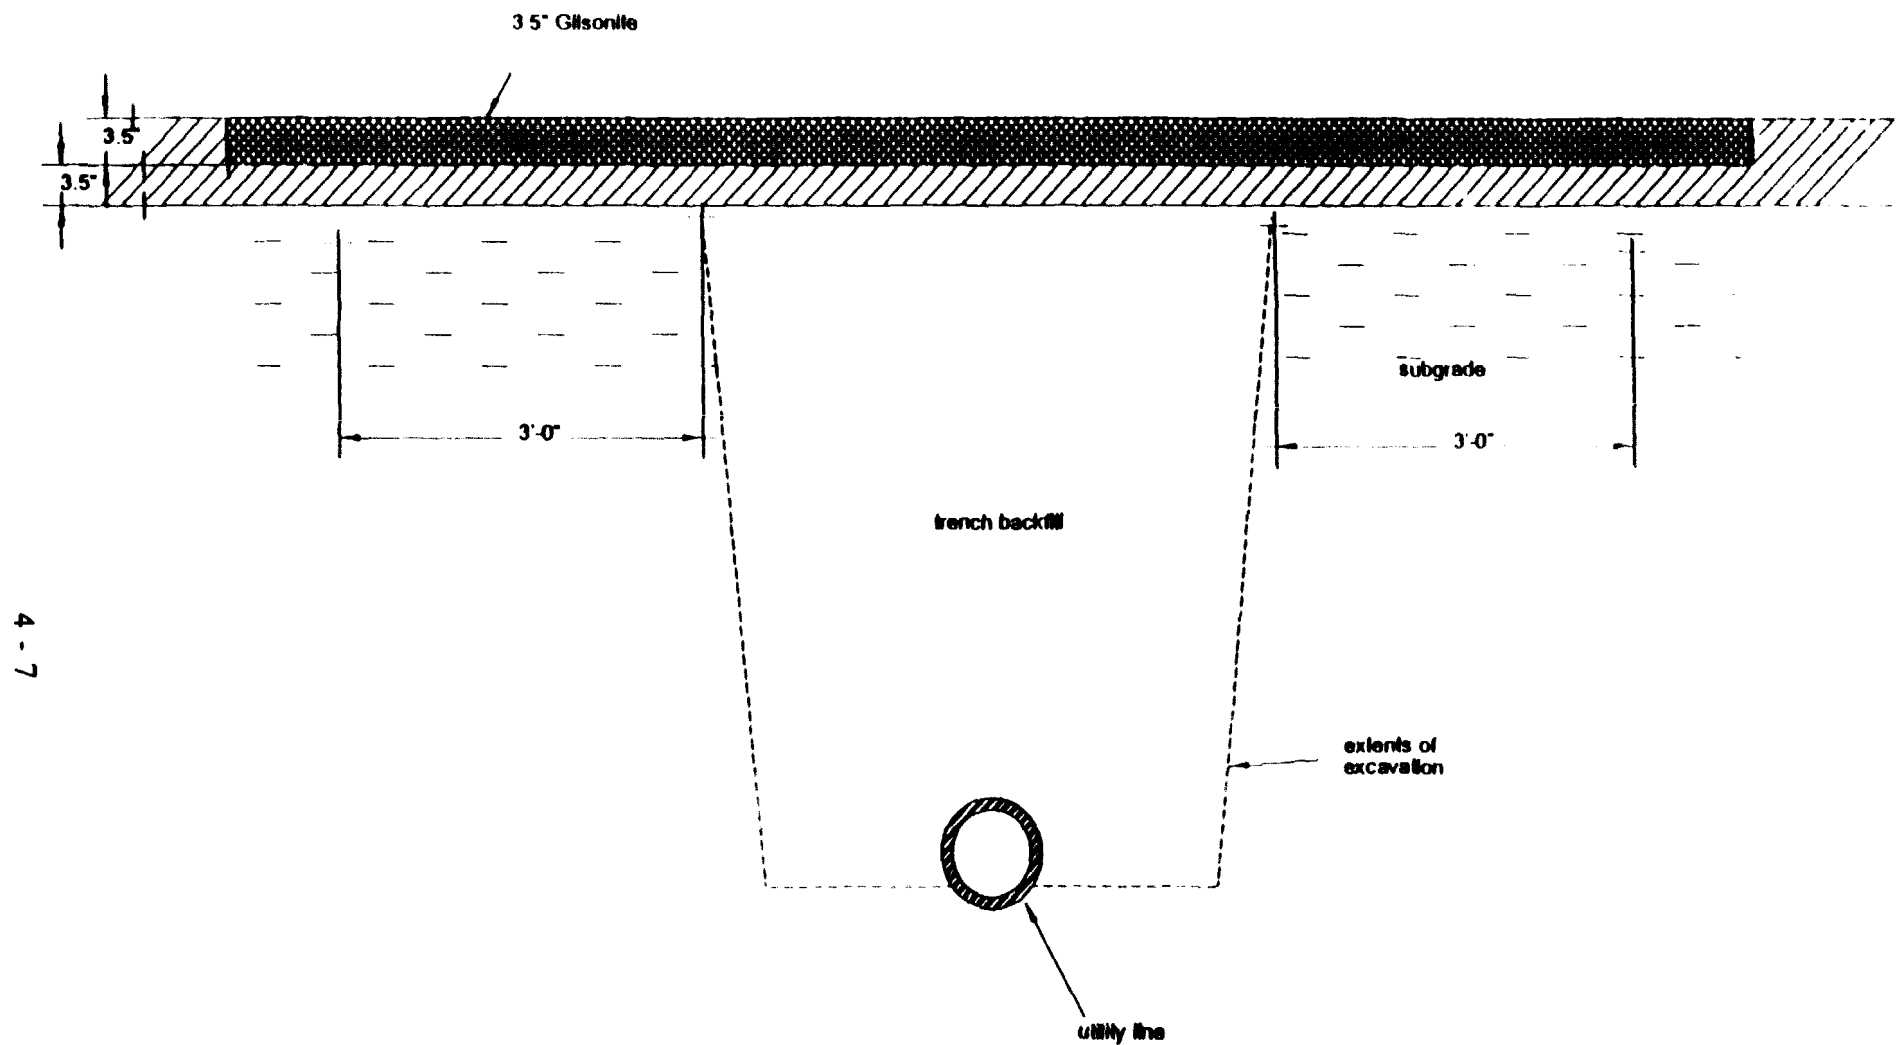
FIG. 4.3. Pavement Strengthening by Replacing a 3.5 in. Thick Portion of AC Pavement with 3.5 in. Thick Gilsonite Asphalt Pad - Scheme 2

Scheme 2 is intended for the restoration of a typical 7 inches thick asphaltic concrete pavement. It uses Gilsonite Asphalt which has approximately 50 percent higher tensile strength than ordinary asphalt. Thus replacing a 3.5 inch thick portion of the 7 inch asphalt with Gilsonite Asphalt would not only replace the removed asphalt, but would also provide additional strength equivalent to an 1.75 inches thick overlay on top of the original pavement. The scheme, therefore, consists of removal of 3.5 inches thick portion of the AC pavement over the cut area and 3 feet beyond the cut edges, and replacing the removed material with Gilsonite Asphalt. This will provide increased strength without changing the thickness of the pavement. The estimated average cost using the Gilsonite repair technique, Figure 4.3, is \$950.

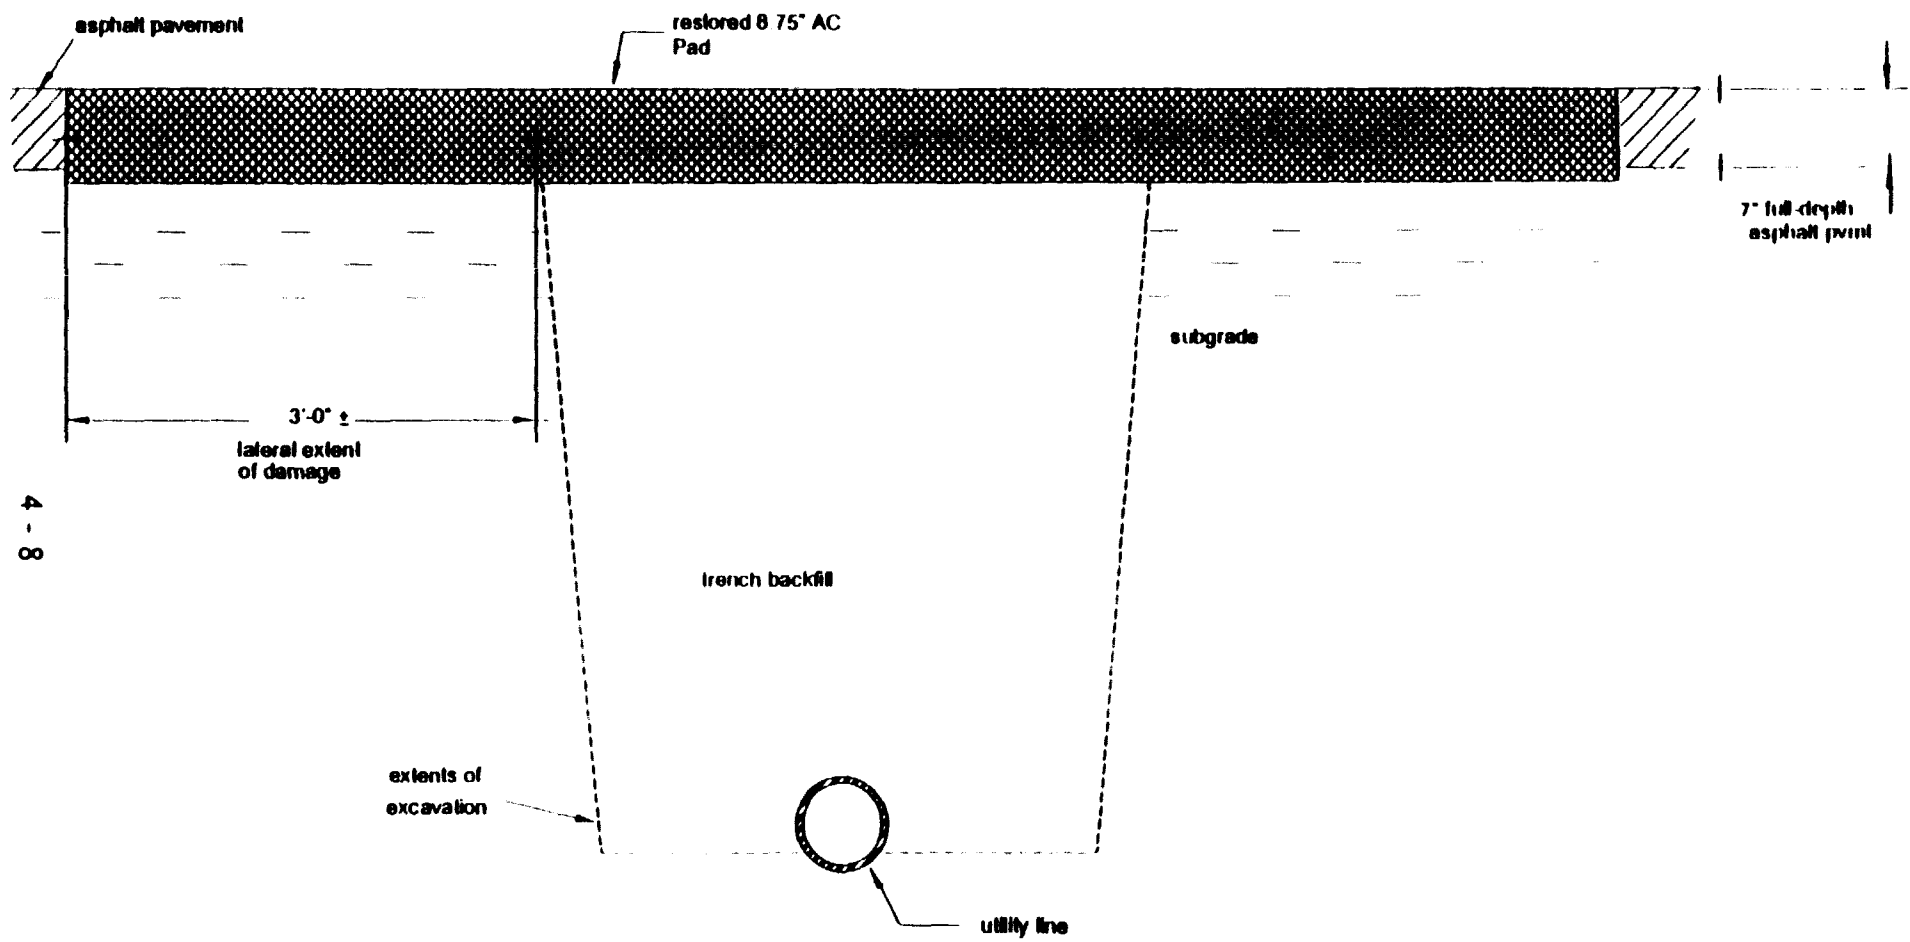
FIG. 4.4. Pavement Strengthening by Replacing the 7 in. Thick AC Pavement with an 8.75 in. AC Pad - Scheme 3

Scheme 3 is intended for the restoration of asphaltic concrete pavement. It consists of removal of the AC pavement and portion of the subgrade over the cut area and 3 feet beyond the cut edges to a depth of 8.75 inches, followed by placement of an 8.75 inch AC pavement over the entire area of 110 square feet. Average cost using this technique, Figure 4.4, is \$1400.
